## Ultrasonic Inspection of Titan IV Stage I Baffles

1 March 1996

J. P. NOKES  
Mechanics and Materials Technology Center  
Technology Operations

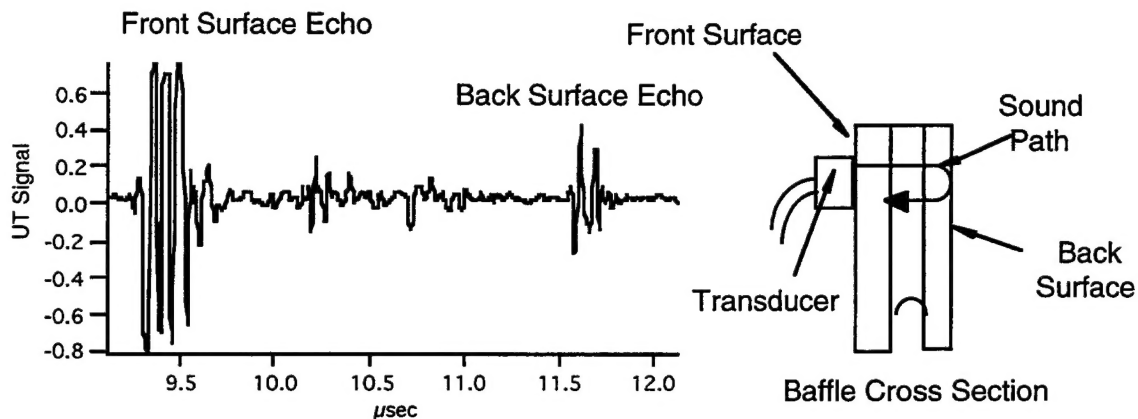
Figure 4. Ultrasonic signal from a baffle rib indicating a good contact between both face plates and the rib.

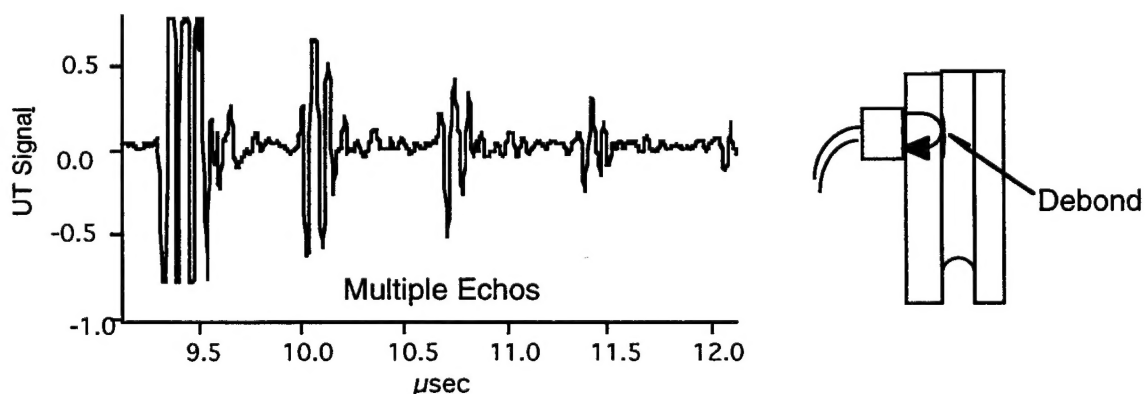
The signal displayed in Figure 5 is typical of the return that would be expected from a front-faceplate/baffle debond. In this case, the ultrasonic pulse travels a path that is equivalent to twice the thickness of the faceplate. As a result, the waveform in Figure 5 is also characteristic of the signal obtained from a position on the baffle between ribs since the normal faceplate/air interface is indistinguishable from that of the faceplate/baffle with a debond.

Figure 5. Ultrasonic signal showing the multiple reflections typical in the front surface debond.

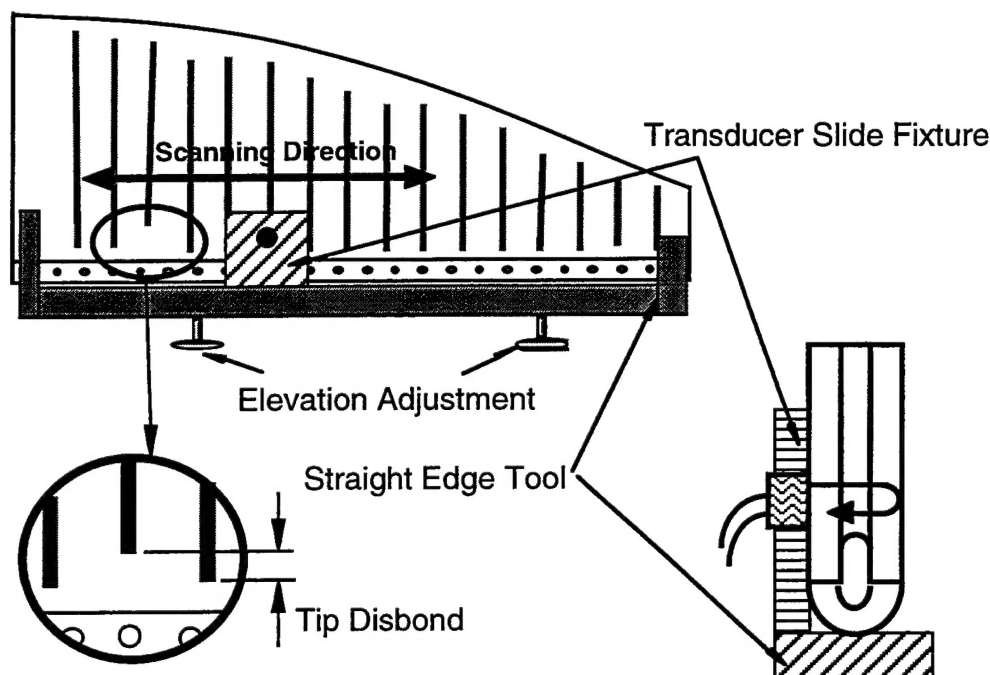
While investigating simulated baffle debonds, difficulties were noted in evaluating debonds at the rib tips. Over the majority of the baffle area, debonds in an individual rib could be located and sized by detecting the edges of the debond area. However, at the rib tips, it was difficult to determine for a particular rib whether the displayed signal indicated an actual debond or simply that the transducer had moved past the end of the rib. The difficulty was exacerbated when an inspection was made in

the combustion chamber without the visual cues found on the bench top. To meet the stated ( $< 0.10$ -in.) resolution requirements, a different approach was taken for inspecting the rib tips. Instead of evaluating each rib individually, a horizontal scan was implemented that compared an individual rib tip to the other 15 ribs, as shown in Figure 6. A Teflon™ tool was used to position the transducer at the desired elevation on the baffle. The fixture allowed for the centerline position of the transducer to be adjusted to account for variations in the hardware. Using this scanning approach and the focused transducer, rib debonds on the order of 0.035 in. could be detected.

Figure 6. Ultrasonic Inspection near the rib tips.
